FORM B – BUILDING

Address: 1006 Massachusetts Avenue

Historic Name: East Lexington Fire Station

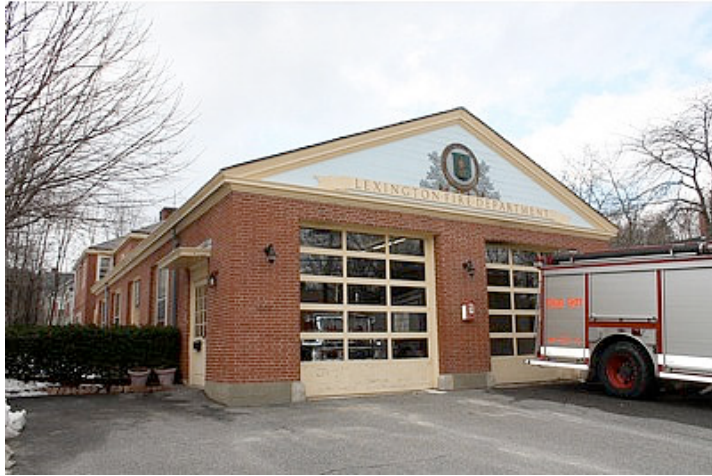
Photograph

Built in a Colonial Revival style, the East Lexington Fire Station is a brick structure constructing of a two-story, hip-roofed section to the west, facing Locust Avenue, and a gable-roofed garage section facing Massachusetts Avenue. Brickwork is laid in a Flemish bond and the roofs are sheathed in slate with a central brick chimney on the rear structure. The Locust Avenue entrance consists of a paneled door capped by transom lights and recessed behind a double-arched portico. A projecting brick beltcourse wraps around the building between the stories. Windows contain wooden 12/12 sash on the first floor with flat arch brick lintels. The second floor openings include 12/12 and 8/12 sash but the tops of the windows extend to the projecting, boxed cornice. The Locust Avenue (north) elevation of the garage is five bays deep with 15/20 windows set into rectangular recesses. There are four windows and an entrance on the south side. The flushboard pediment facing Mass. Ave. over the two garage doors is decorated by a painted town seal and ribbon sign reading "Lexington Fire Department".
